Department of the Interior

Aviation Safety Review

Fiscal Year 99

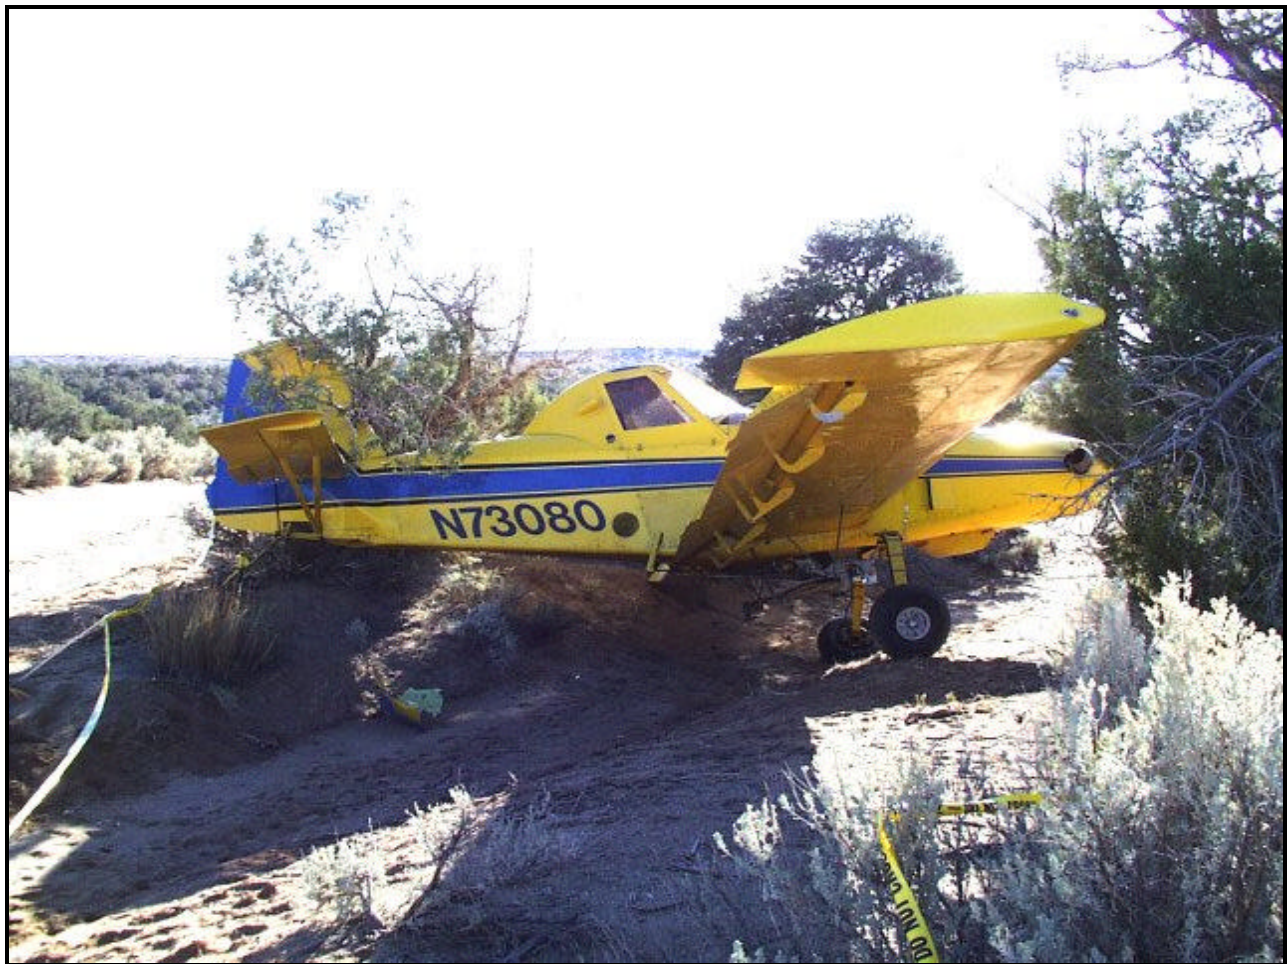
**AIRCRAFT ACCIDENT
99-9F01-C-LLM**

Narrative: On October 19, 1998, approximately 1300 Mountain Daylight Time, an Air Tractor AT-400, N73080, operated by J.R. Davis Flying Service under contract to the U.S. Bureau of Land Management, was substantially damaged during a forced landing near Aztec, New Mexico. The airline transport pilot, the sole occupant aboard, was not injured. Visual meteorological conditions prevailed, and no flight plan had been filed for the aerial application flight being conducted under

Title 14 CFR Part 137. The flight originated at Aztec, New Mexico, at approximately 1230. According to the pilot's accident report, he had flown the aerial application flight for 12 minutes when he began to "get oil on the windshield, and began losing oil pressure." A precautionary landing ensued. During the landing roll, the right wing struck a tree. The airplane spun around and slid sideways, collapsing the left landing gear. The left wing was also "wrinkled." The pilot said he found that the oil dipstick had not been secured.

Pilot reported the oil dipstick was not secured.

Probable Cause: The National Transportation Safety Board determines that the probable cause of this accident was the pilot's inadequate preflight inspection of the airplane.

Contributing Factors: Factors in the accident were the unsecured oil dipstick, the loss of engine oil pressure necessitating a precautionary landing on unsuitable terrain, and the collision with the tree.

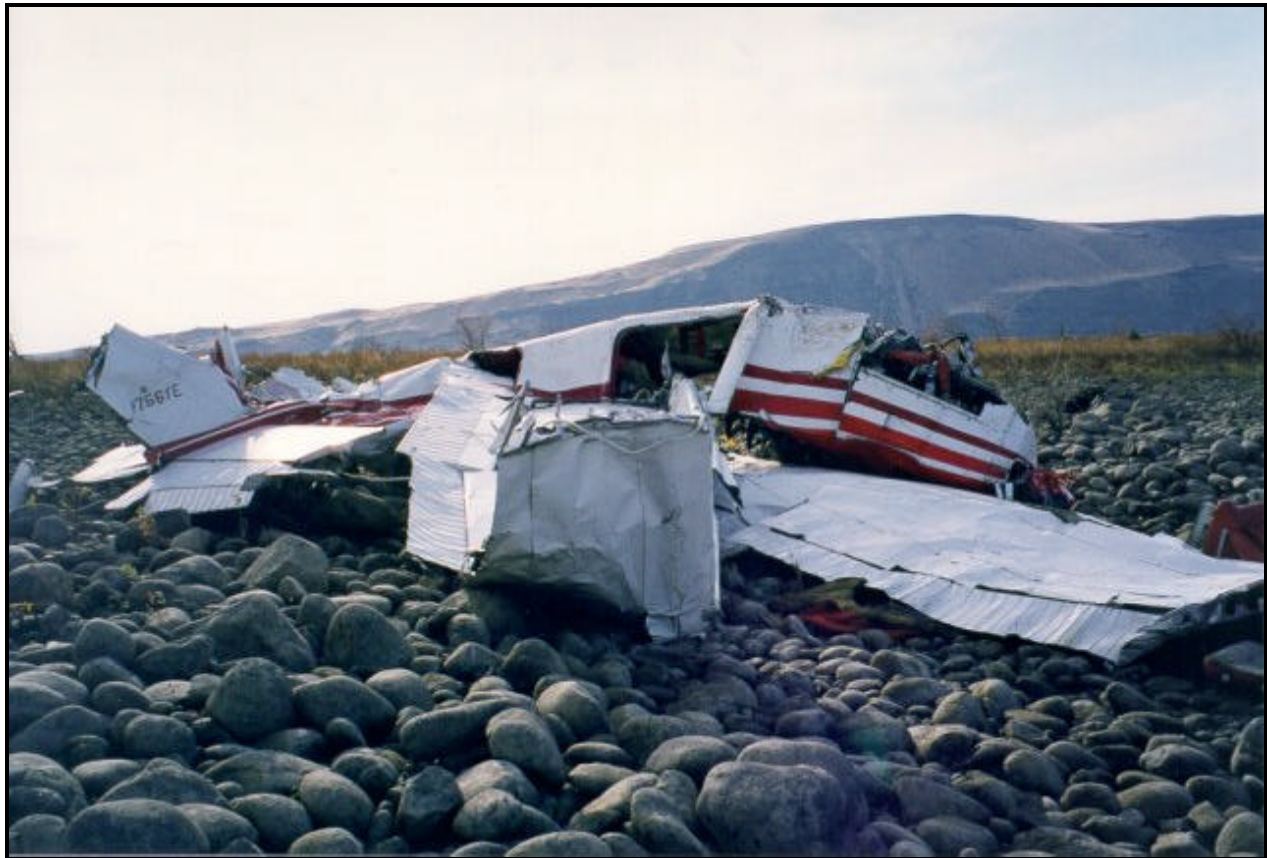
AIRCRAFT ACCIDENT
99-9F02-A-FWS

Narrative: On November 6, 1998, approximately 1225 Pacific Standard Time, a Cessna TR182, N756YE, operated by Kennewick Aircraft Services Inc. of Kennewick, Washington under contract to the U.S. Fish & Wildlife Service as a public-use waterfowl survey flight, struck power lines across the Columbia River near Desert Aire, Washington, and subsequently crashed and sank into the river. The airplane sank to the river bottom (approximately 15 feet deep), the commercial pilot-in-command of the aircraft was able to escape the aircraft and was rescued by a boat on the

river, but sustained serious injuries in the accident. Two U.S. Fish & Wildlife Service employees aboard the aircraft, who were acting as observers for the waterfowl survey, did not escape the submerged aircraft and were fatally injured. The flight departed Vista Field, Kennewick, Washington, and was to have been a local flight. Visual meteorological conditions were reported at the Hanford, Washington, weather observation station (approximately 9 nautical miles southeast of the accident site) at 1150. The airplane was not on a flight plan. The operator possessed an FAA waiver from the minimum altitude requirements of 14 CFR 91.119(c). This waiver authorized the pilot to operate at altitudes below 500 feet above ground level (AGL) on aerial survey flights, provided aircraft were not operated closer than 500 feet to persons on the surface. Witnesses reported that at the time of the accident, the airplane was flying eastbound (downstream) at low altitude. The airplane struck the power lines which cross the river between the Priest Rapids Dam and the Vernita Bridge (where Washington State highway 24 crosses over the river), approximately 2 miles west of the Vernita Bridge. There are two groups of transmission lines which cross over the river at this point, a westernmost (upstream) group mounted on towers rising to approximately 194 feet AGL and an easternmost (downstream) group on taller towers. The transmission line support towers on each riverbank are depicted as group obstructions on the Seattle Sectional Aeronautical Chart, with the chart depicting the towers as being 280 feet AGL. The airplane struck and severed ground/support cables running between the tops of the westernmost group of towers. The FAA on-scene investigator reported that the cables the aircraft struck were 5/8 inch in diameter (the high-tension cables, mounted on supports below the tops of the towers, are approximately 1 inch in diameter.) In an initial interview with the FAA investigator, the pilot told the FAA investigator that at the time he struck the power lines, the airplane was flying due east, climbing at 300 feet per minute, and was at an airspeed of 80 knots. The FAA investigator reported that the pilot told him the airplane was operating normally at the time of the wire strike, and that he was using the towers as a visual reference to indicate how high he was above the power lines. Sky conditions reported in the 1150 Hanford weather observations were: few clouds (up to 2/8 sky cover) at 800 feet; scattered clouds at 25,000 feet; and visibility 15 statute miles.

No flight plan or flight following established.

Personal Floatation Devices (PFDs) not used.

Minimum 500' clearance from persons, vehicles, vessels, and structures (including wires) not maintained.

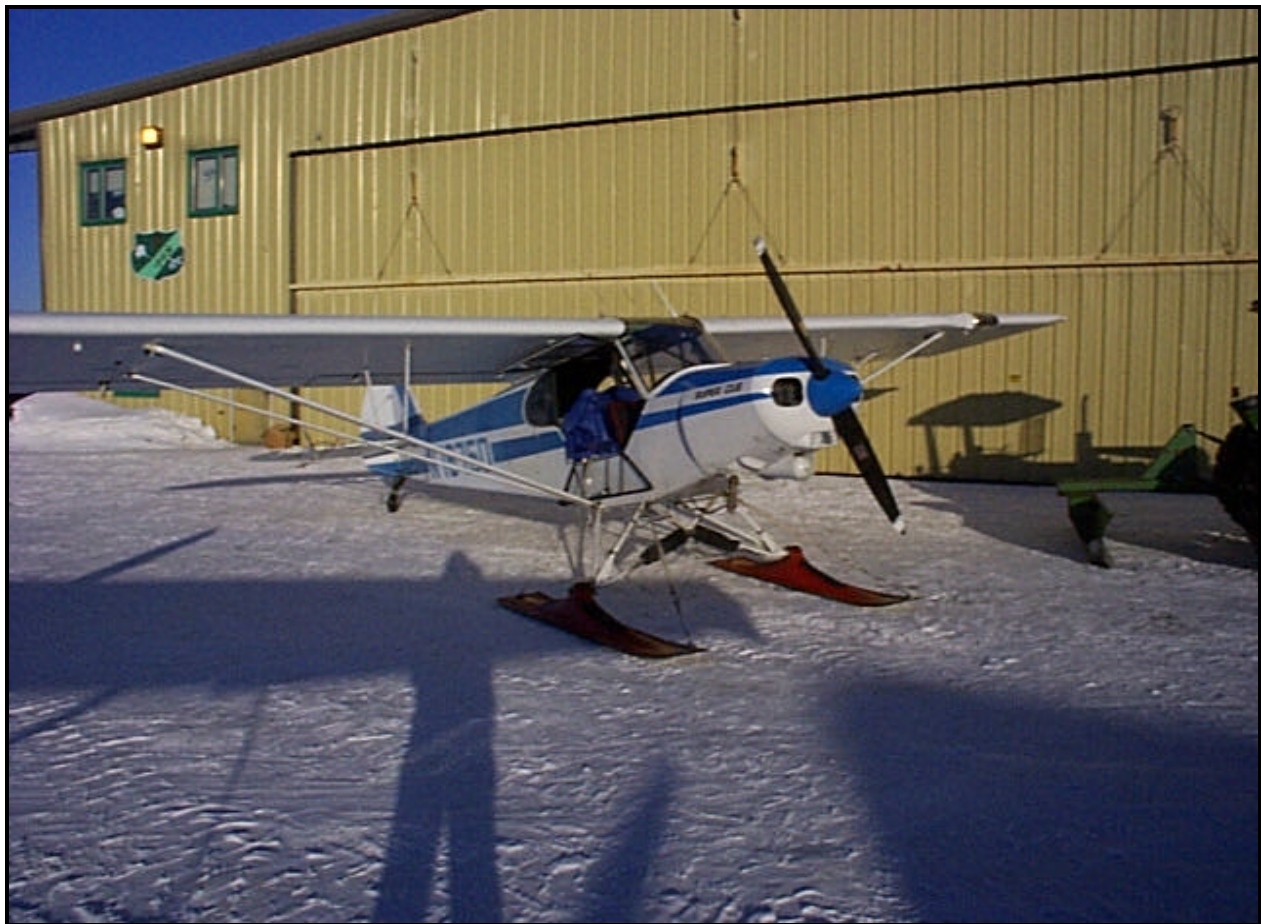
**AIRCRAFT ACCIDENT
99-9E01-O-PAS**

Narrative: On February 3, 1999, about 1030 Alaska Standard Time, a ski equipped Piper PA-18-150 airplane, N7875D, sustained substantial damage while taxiing at Lake Hood, Anchorage, Alaska. The airplane was being operated as a visual flight rules (VFR) local area flight when the accident occurred. The airplane was operated by the U.S. Department of the Interior, on a public use mission. The solo airline transport pilot was not injured. Visual meteorological conditions prevailed, and VFR company flight following procedures were in effect. In his written statement

to the National Transportation Safety Board, the pilot reported that he was returning to a maintenance vendor's hangar after completing a maintenance operational check flight. He said that while taxiing on an ice covered parking area, he applied power to taxi up a small incline. He said that as the airplane's skis went over the top of the incline, he closed the throttle, and reached for mixture control cut off. He noted that his sleeve caught on the throttle control, advancing it to the open position. He said that he was unable to stop the airplane, and the left wing struck a parked maintenance tug. The left wing sustained substantial damage. The pilot noted that there were no pre-accident mechanical anomalies with the airplane.

The pilot said that given the parking and surface conditions, this was a marginal area for operations on skis. With the inadvertent addition of power, he was unable to stop safely in the space available.

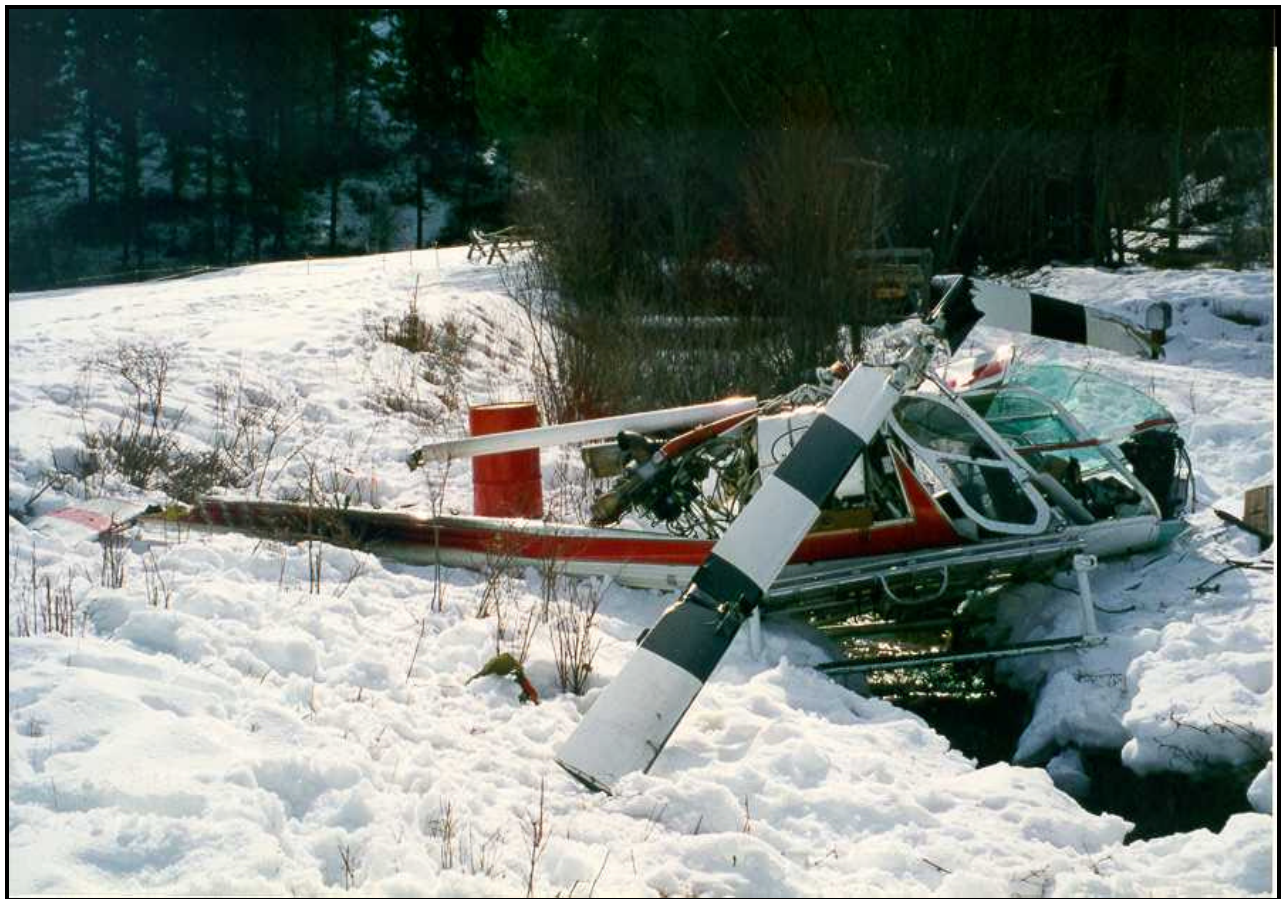
**AIRCRAFT ACCIDENT
99-9F03-N-IFG**

Narrative: On February 28, 1999, about 1330 Mountain Standard Time, a Hiller UH-12E, N2239, registered to and operated by Valley Helicopter Service, was substantially damaged after it collided with terrain while landing at Taylor Ranch airstrip, located 28 nautical miles northeast of Yellow Pine, Idaho. A company visual flight rules (VFR) flight plan was filed for the 14 CFR 135 aerial observation flight. The commercial pilot and his two passengers were uninjured. The flight originated from Taylor Ranch approximately ten minutes prior to the accident. The operator was

contracted by the Idaho Department of Fish and Game, to survey for elk in the Frank Church Wilderness Area. The pilot, accompanied by two observers, departed the airport for the second surveillance flight of the day. Shortly after departure, the pilot was contacted by a ground crew member and informed that during the departure, a 55-gallon fuel barrel was knocked over. The pilot elected to return to the airport to inspect the helicopter for possible damage. The pilot made a normal approach to the airport and was established in a hover taxi, about 20 feet AGL, when the helicopter suddenly began to descend. The pilot stated he pulled full up-collective, however the helicopter continued to descend and impacted terrain in a slightly nose-low attitude. After contacting the ground, the pilot released the collective and the main rotor blades struck and severed the tail boom. At the time of the accident, the helicopter was operating near maximum gross weight limits at an elevation of 3,835 feet mean sea level (MSL). The pilot stated the engine was producing rated power and there were no indications of a powerplant failure. The weather at the accident site, as reported by the pilot, was 50 degrees Fahrenheit, winds calm, and a visibility of 15 miles. The main cabin area was intact, but sustained substantial impact damage. The left skid was partially collapsed. The tail boom was severed and leading edge damage was noted to the main rotor blades. Control continuity was maintained from the cyclic to the cyclic pylon assembly and from the collective to the control rotor assembly. Four bolts that secure the ballast plate to the rotor assembly were found fractured. The assembly was removed and shipped to the NTSB materials lab for inspection. A metallurgist from the lab reported that the all four bolts displayed features that are consistent with overstress separation.

The pilot stated that the engine was producing rated power and there were no indications of a powerplant failure.

The aircraft was operating near the maximum allowable gross weight at an elevation of 3835 feet MSL at the time of the accident.

One of the passengers reported the main rotor stabilizer entered the cockpit through the bubble canopy and struck the base of the pilot's seat narrowly missing the pilot and passenger.

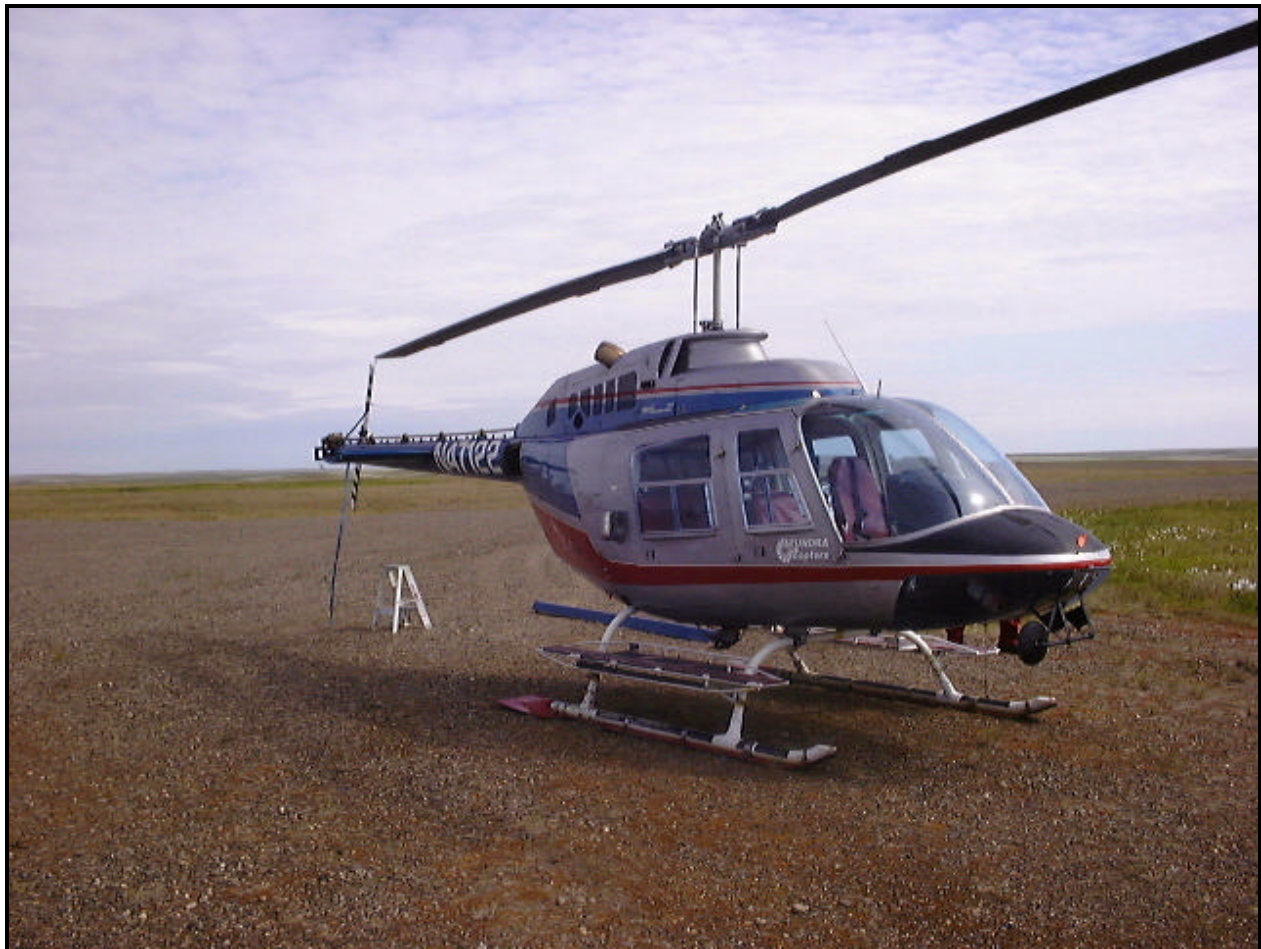
**AIRCRAFT ACCIDENT
99-9E02-C-LLM**

Narrative: On July 8, 1999, about 1230 Alaska Daylight Time, a Bell 206B-III helicopter, N47122, sustained substantial damage during engine start-up, about 75 miles southwest of Deadhorse, Alaska. The helicopter was being operated as a visual flight rules (VFR) U.S. Government flight by the U.S Department of Interior, Bureau of Land Management, Fairbanks, Alaska, when the accident occurred. The helicopter, provided by Tundra Copters Inc.,

Fairbanks, Alaska, was an on-demand 14 CFR Part 135 flight. The certificated commercial pilot, and the three passengers, were not injured. Visual meteorological conditions prevailed. Company VFR flight following procedures were in effect. During a telephone conversation with the National Transportation Safety Board (NTSB) investigator-in-charge (IIC), on July 8, 1999, the Director of Operations for Tundra Copters Inc. reported the pilot loaded his passengers into the helicopter at a remote biological survey site. The pilot then began an engine start, but a main rotor blade tiedown strap was still attached to one of the rotor blades. As the rotor blades began to turn, the strap struck the helicopter's vertical stabilizer. The helicopter received damage to the tail boom, and the stabilizer.

Break in habit pattern, resulting in failure to ensure that main rotor tiedown was properly removed. Many pilots set main rotor (2 bladed) at the 3:00/9:00 position and check during pre-start. Crew/passengers be vigilant.

Inadequate preflight inspection of the helicopter.

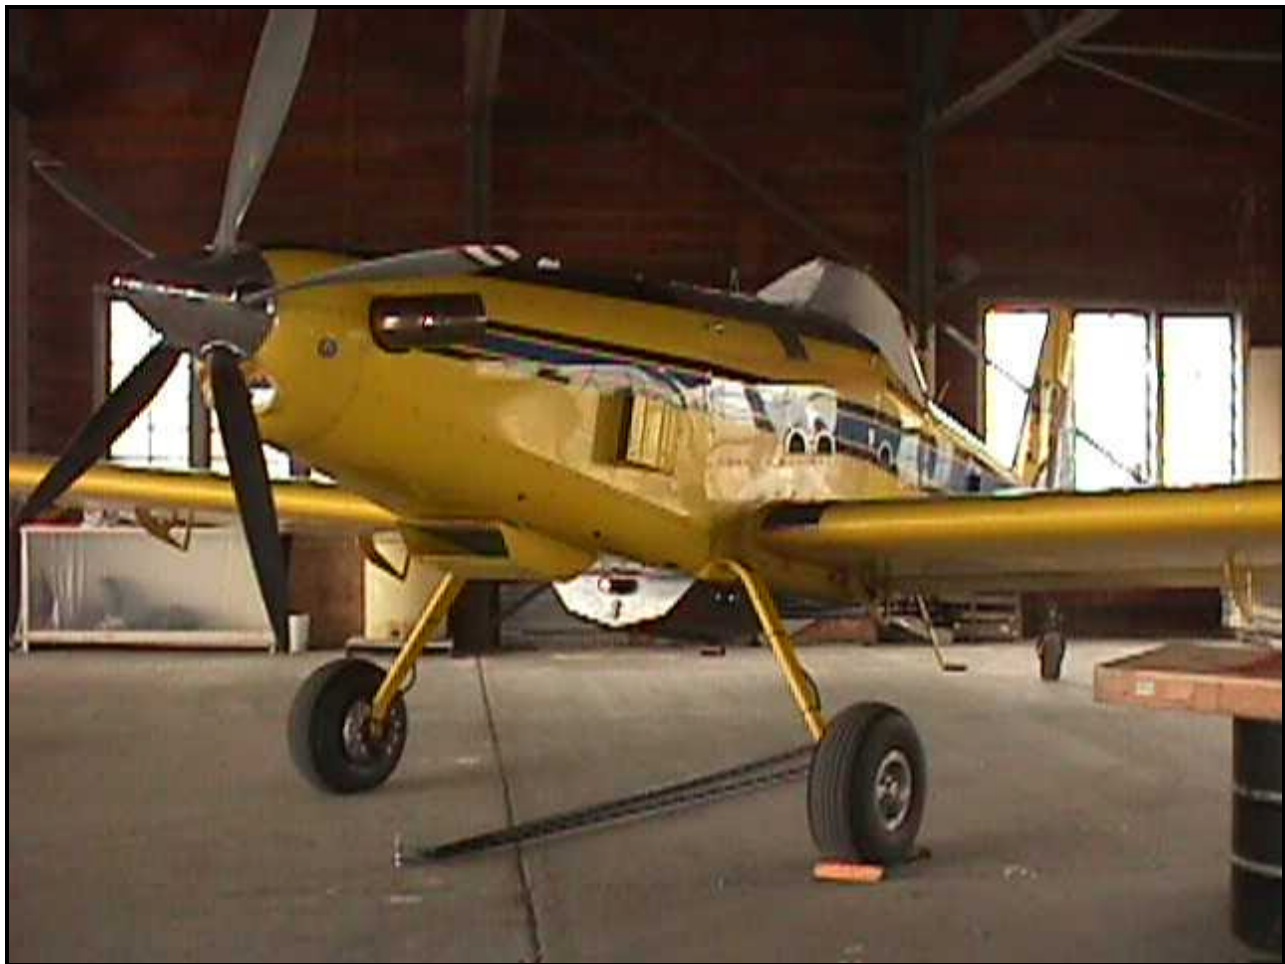
**AIRCRAFT ACCIDENT
99-9F04-C-LLM**

Narrative: On August 19, 1999, at 1426 hours Pacific Daylight Time, an Air Tractor AT-802A, N9190G, collided with a tree during a fire fighting aerial retardant application near Elko, Nevada. The aircraft was operated as a public-use aircraft under contract to the U.S. Department of the Interior, Bureau of Land Management (BLM), for wildfire suppression operations. Visual meteorological conditions prevailed for the local area aerial application operation. The aircraft

sustained substantial damage. The commercial pilot, the sole occupant, was not injured. The flight originated about 1400 hours at the Elko airport on the day of the accident and was responding to a wildfire on BLM land. The pilot reported that he was following a larger aircraft on a fire application run. He successfully dropped half his retardant load on the fire and went around for another run. On the second pass, the pilot stated the aircraft encountered a strong downdraft as it neared the release point and the pilot recovered at a low altitude. During this process, the left outer wing collided with the top of a juniper tree. The pilot returned to Elko and landed. The outboard four feet of the wing leading edge was crushed aft and sustained rib damage.

The pilot failed to maintain 40 foot terrain clearance as required by contract.

There were no lead planes or air attack in the immediate vicinity to provide oversight and assistance during this drop.
